3.0 Existing Conditions

3.1 Adaptive Reuse Areas

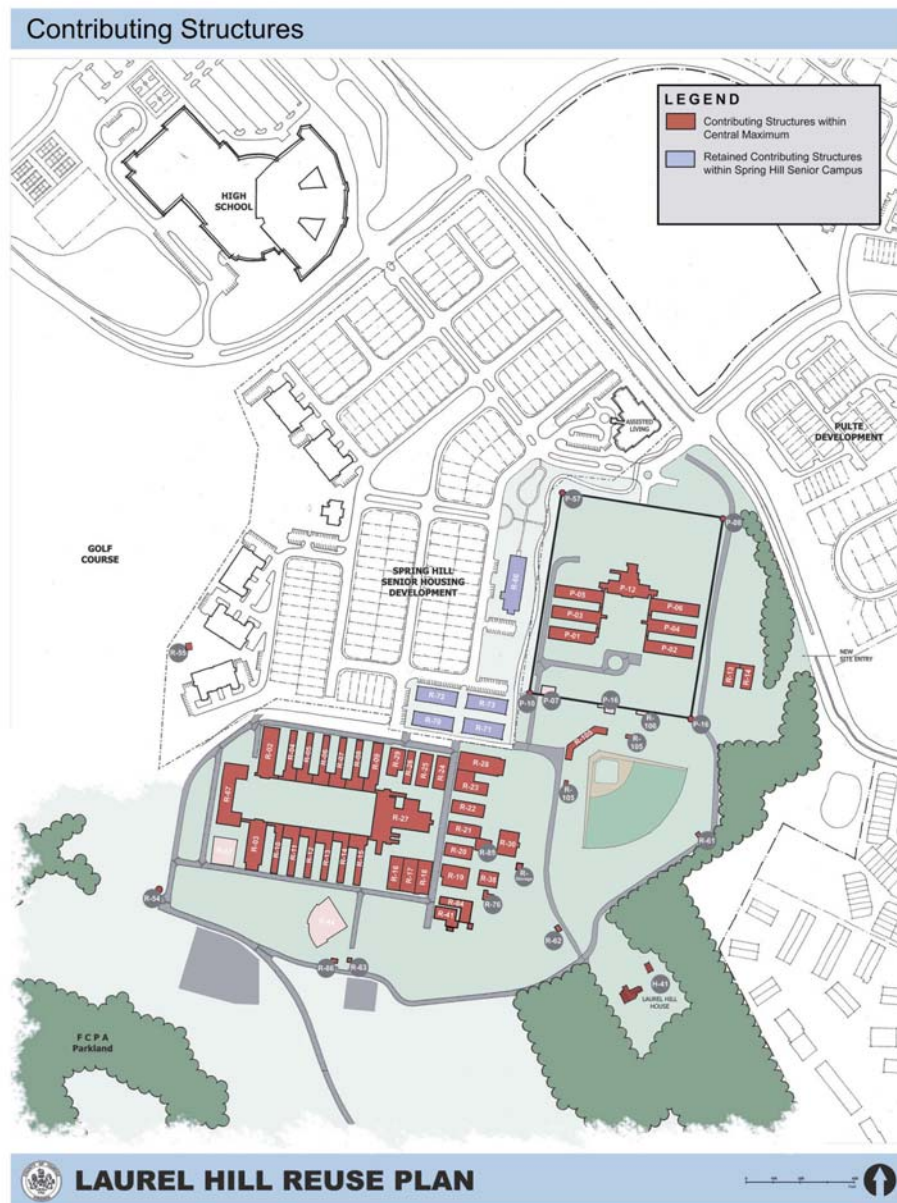
Figure 5: Existing Structures within the Reformatory and Penitentiary Area

The Reformatory and Penitentiary adaptive reuse area consists of 79 acres located along Silverbrook Road between Lorton Road and Hooes Road. The site includes more than 70 buildings. As shown in Figure 5, the site is largely developed by existing buildings and limited parking, limited recreation space. The following section provides a description of the contributing buildings that will impact the reuse of the reformatory and penitentiary areas that comprise the Reformatory and Penitentiary Area.

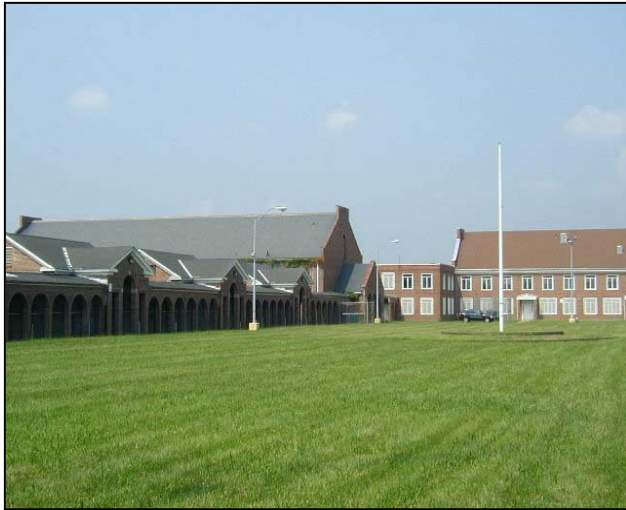
Figure 8: Interior View of Reformatory Quadrangle

Twelve dormitory buildings, an auditorium/ hospital and a gymnasium comprise the north and south sides of the quadrangle. There is a large dining hall at the east end and an administration building on the west side. Although the gymnasium and the administration building were constructed after the period of significance, they are considered contributing resources because their location and design echo the historic plan. Behind the east end of the quadrangle there is a consistently massed and sited row of buildings originally used as industrial shops. Additionally, there is a series of buildings located to the north and south of the dining hall, outside of the quadrangle. The massing and placement of these buildings form repetitive patterns. There is a network of steam tunnels underneath the central quadrangle of the reformatory.

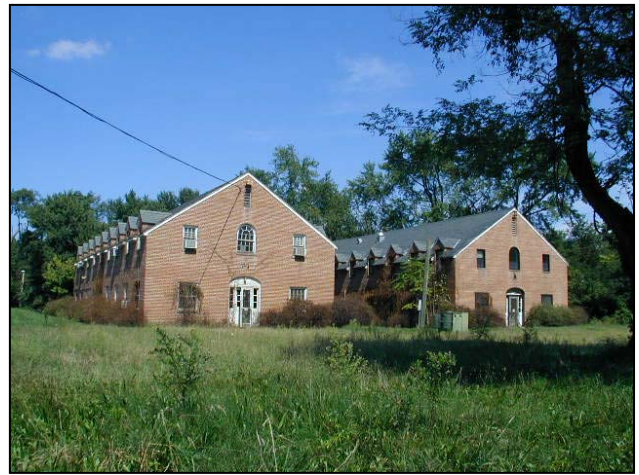
Figure 7: View of Officers' Quarters

Two additional buildings are located east of the penitentiary, which is shown in Figure 7. Known as the Officers Quarters, these buildings are historically associated with the reformatory and the penitentiary. Designed as identical structures and sited parallel to each other, the two buildings are enclosed at one end to form a front-facing U ground plan.

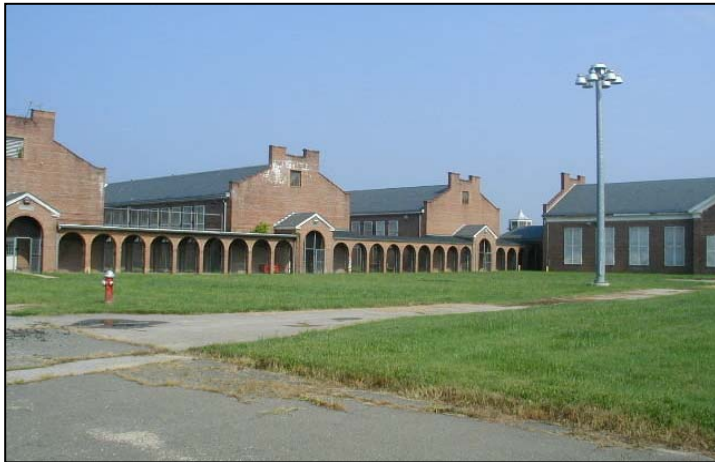
Figure 12: Interior View of Quadrangle

architecture and the high level of architectural detailing are representative of the same design philosophy. The penitentiary quadrangle is comprised of six-gable end cell buildings with decorative parapets and false chimneys, three on each side of a large dining hall. An arcade extends down both sides of the open-ended quadrangle with arched porticos accentuating the entrance to each cell building.

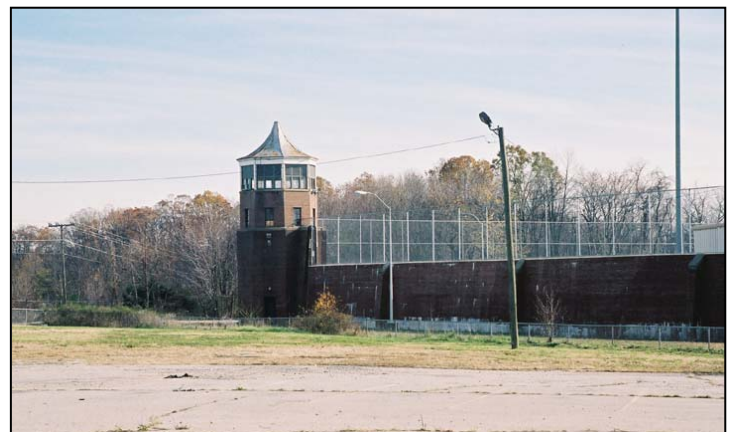
Figure 13: View of Penitentiary Wall from Silverbrook Road

The landscape within the quadrangle is minimal, with lawn areas and partially paved sidewalks and parking areas screening basic utilitarian purposes of the prison. A key view of this quad is from Silverbrook Road where the wall, towers and roofs of buildings are visible to passersby.
